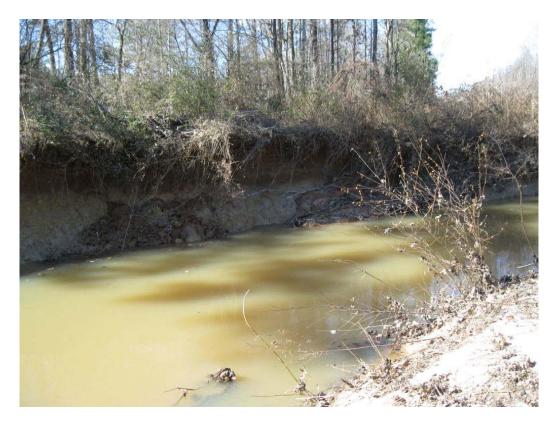
Figure 1 -View of streambank scour upstream of Upper Hembree Road.

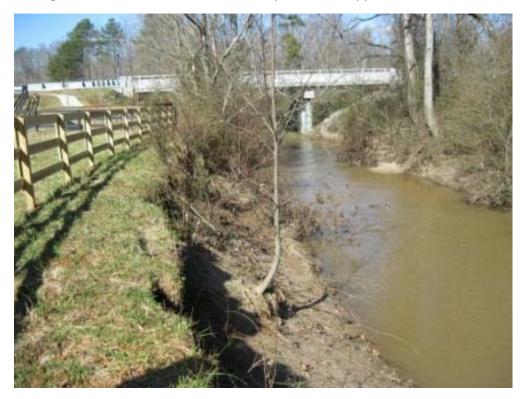
Figure 2 - View of upper bank failure south of Upper Hembree Road near horse farm.

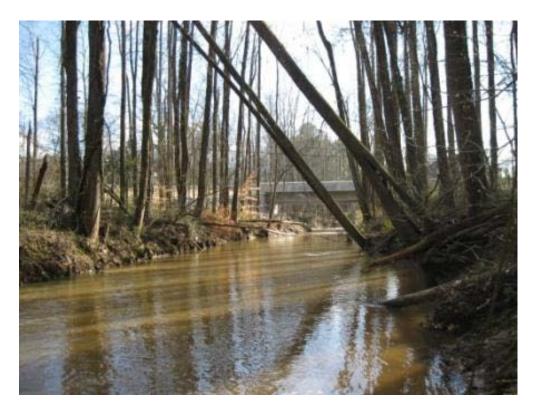
Figure 3 - View of trees along stream bank north of Hembree Road.

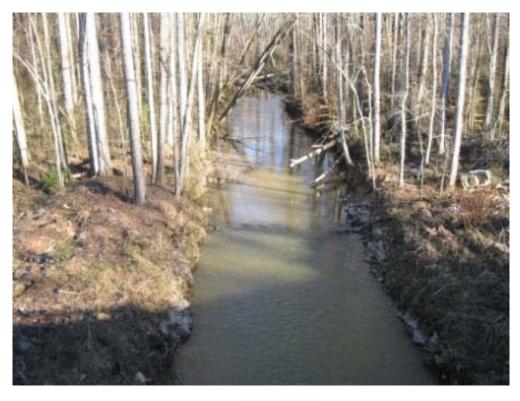
Figure 4 - View of Foe Killer Creek from bridge at Hembree Road.

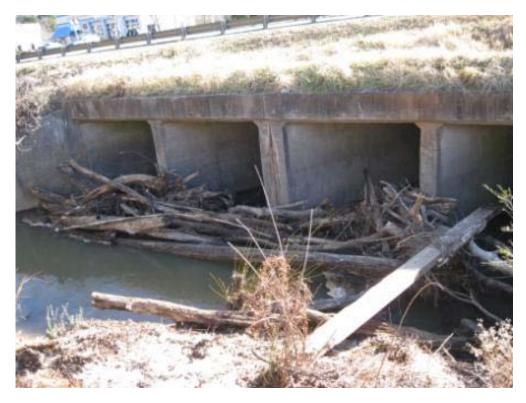
Figure 5 - View of obstructed box culvert at Alpharetta Highway.

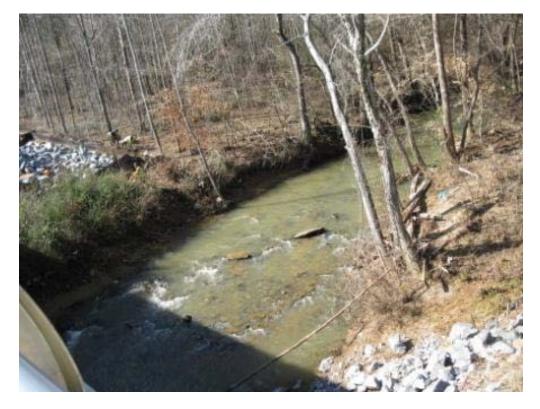
Figure 6 - View of Foe Killer Creek from bridge at Old Roswell Road.

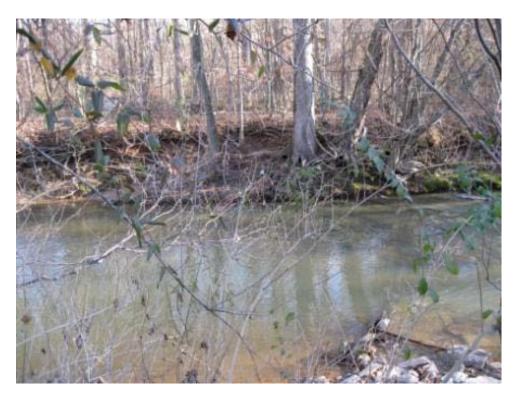
Figure 7 - View of stream bank scour near Rock Mill Way.

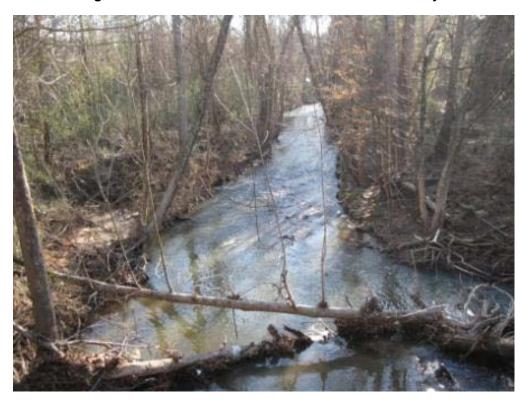
Figure 8 - View of stream obstruction from bridge near Rock Mill Way.

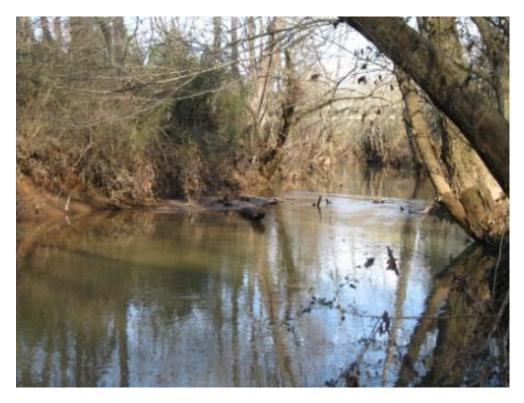
Figure 9 - View of stream bank scour near Davis Drive.

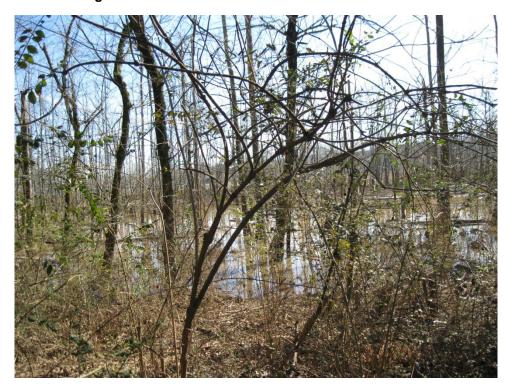
Figure 10 -View of wetland area near Foe Killer Creek near Georgia Highway 400.
