ADA TITLE II TRANSITION PLAN

ADA TITLE II TRANSITION PLAN
OF
CITY OF ROSWELL

ROSWELL, GEORGIA 30075

June 21, 2023

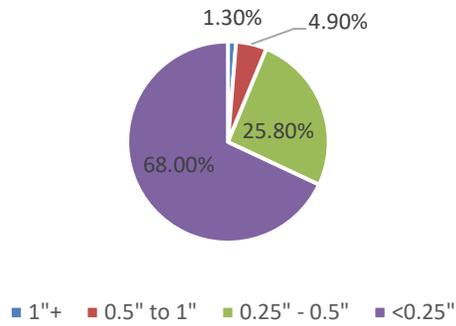
Abrupt Vertical Level Changes

1" +	1.3%
0.5" to 1"	4.9%
0.25" - 0.5"	25.8%
<0.25"	68.0%

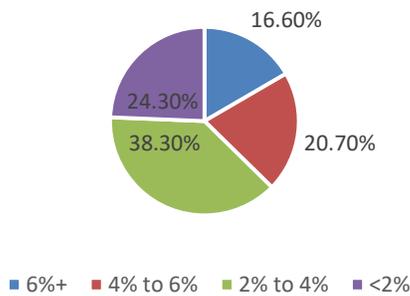
Sidewalk Cross Slope

6%+	16.6%
4% to 6%	20.7%
2% to 4%	38.3%
<2%	24.3%

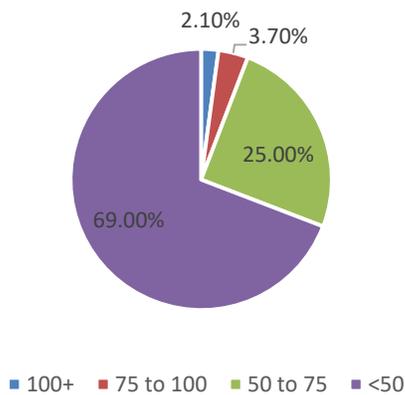
Sidewalk Roughness

100+	2.1%
75 to 100	3.7%
50 to 75	25.0%
<50	69.0%

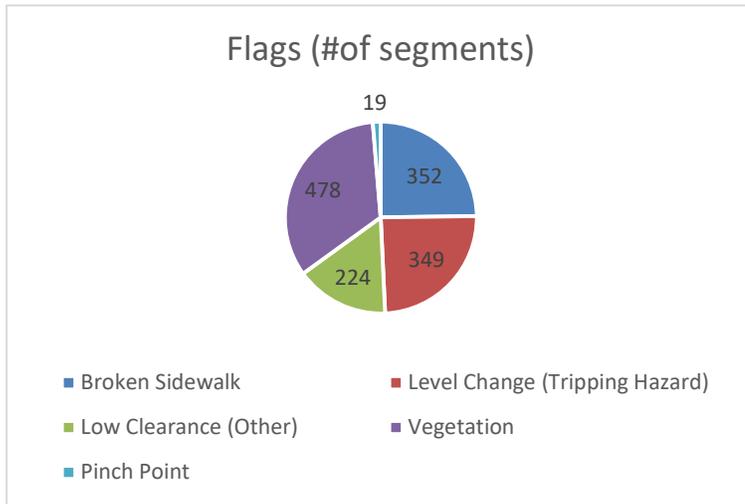
Flags	
Broken Sidewalk	352
Level Change	349
Low Clearance	224
Vegetation	478
Pinch Point	19

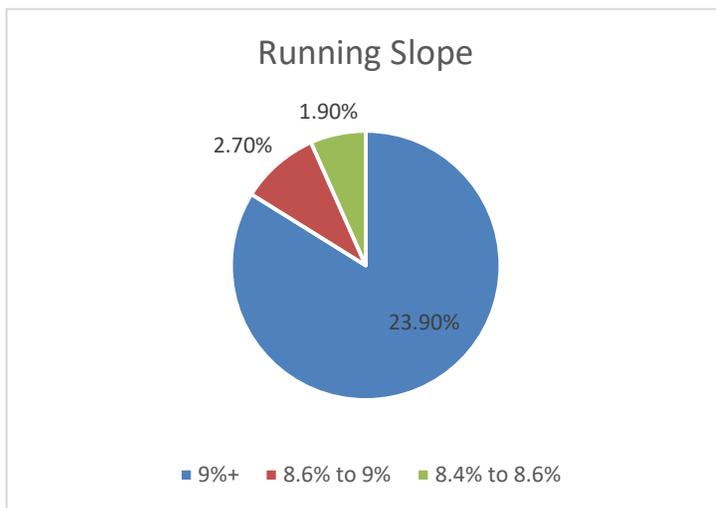
Running Slope %	Percentage
9%+	23.90%
8.6% to 9%	2.70%
8.4% to 8.6%	1.90%

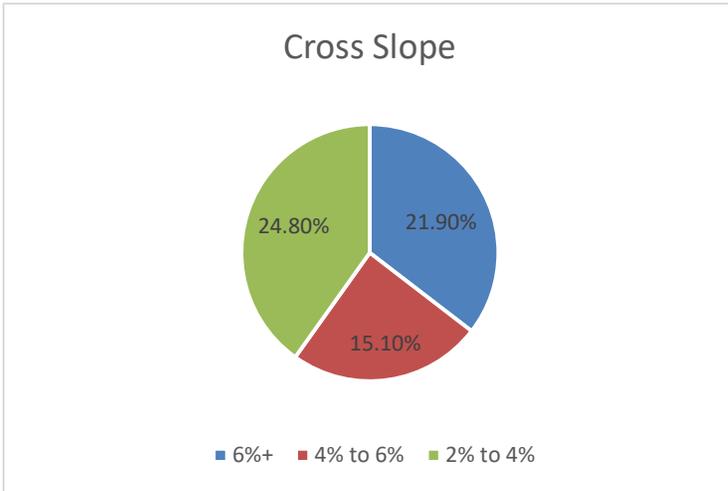
Cross Slope %	
6%+	21.90%
4% to 6%	15.10%
2% to 4%	24.80%

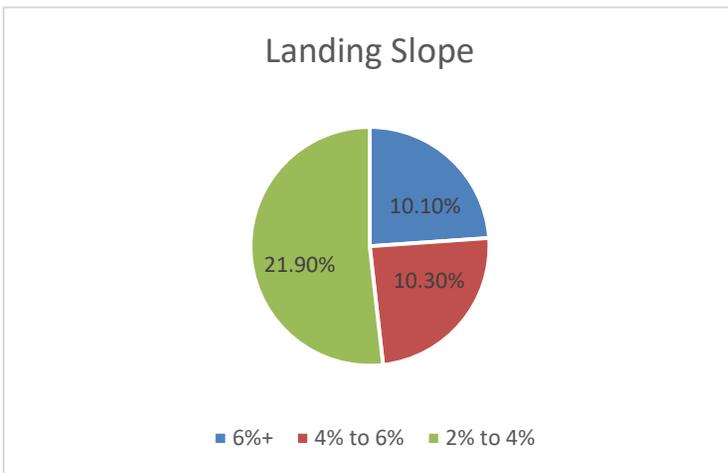
Landing Slope	
6%+	10.10%
4% to 6%	10.30%
2% to 4%	21.90%

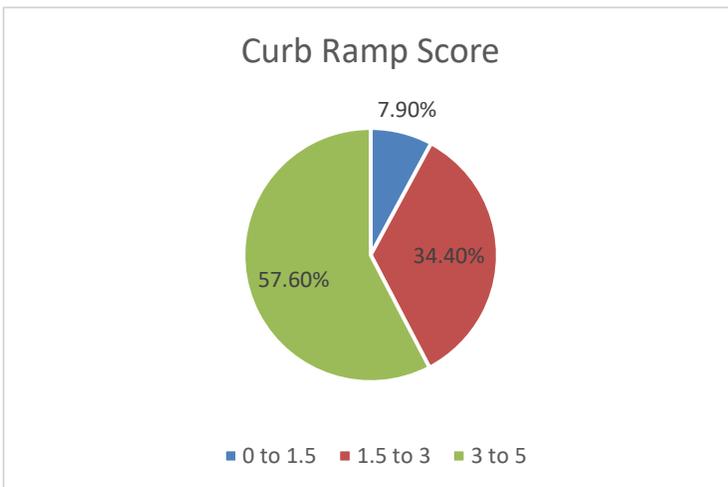
Score	
0 to 1.5	7.90%
1.5 to 3	34.40%
3 to 5	57.60%

The curb ramp score is a weighted calculation of the various measured attributes including slopes, width, obstructions, and the presence of detectible warning. Missing curb ramps are given a score of 0.

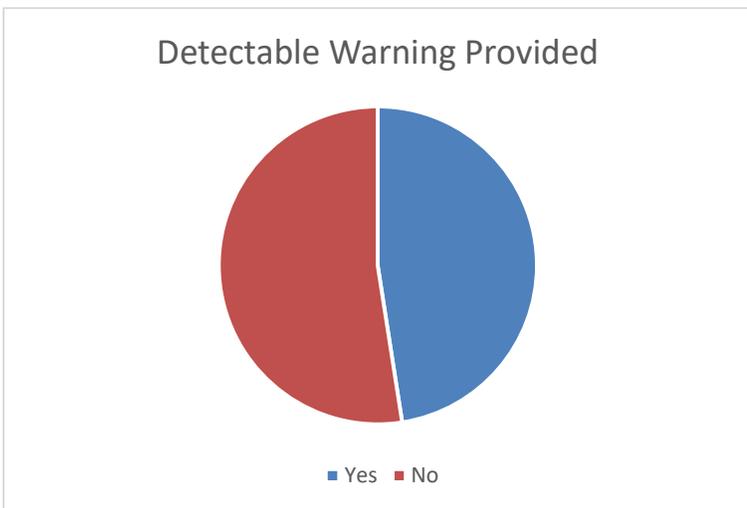
Detectable Warning	
Yes	47.40%
No	52.30%
